## BILATERAL TOTAL KNEE ARTHROPLASTY FOR COMPLEX METAL INCOMPATIBILITY

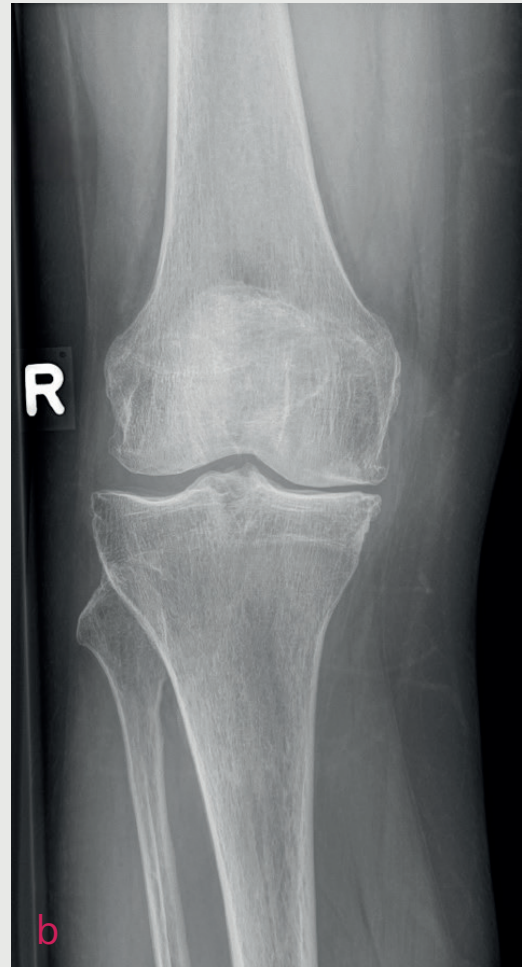
Fig. 1 Preoperative radiograph on the right, (b) a.p. projection

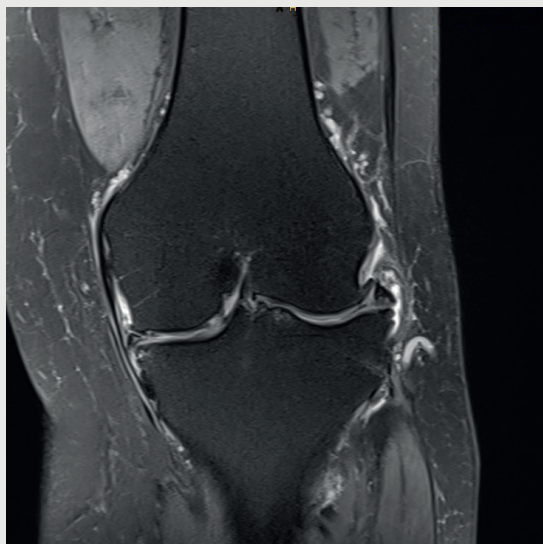
Fig. 6 Preoperative MRI imaging left

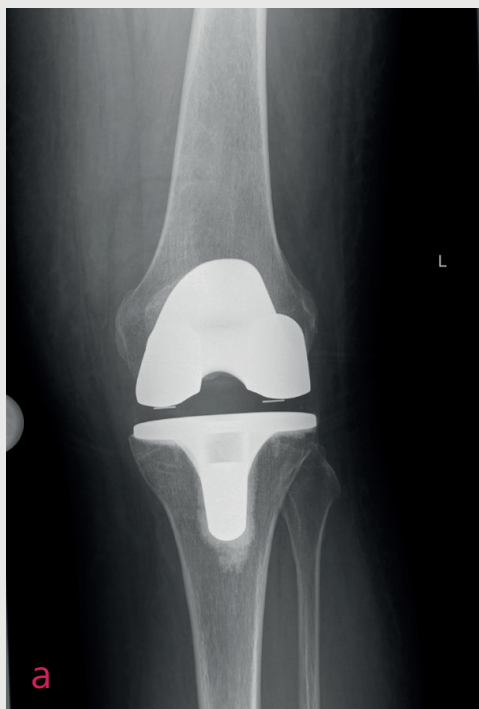
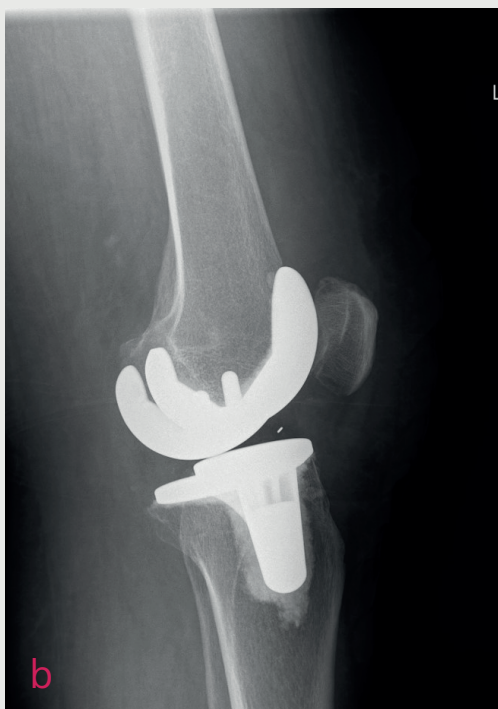
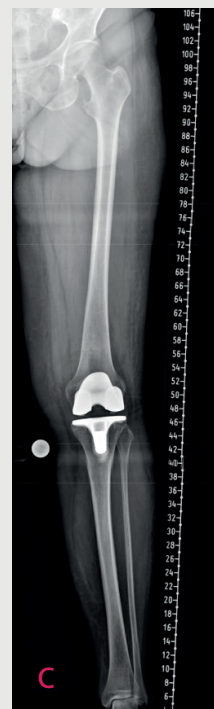
Fig. 8 Postoperative radiological control on the left (a) in a.p. projection, (b) in m.l. projection and (c) whole-leg radiograph in a.p. projection, control of the knee axis and implant position

The clinical-radiological follow-up examinations showed correct positioning of the total knee arthroplasty implants without signs of loosening or implant-related complications. The bilateral knee replacement with the all-ceramic BPK-S Integration Ceramic knee system proved to be a successful, reliable treatment and led to a good functional result. The patient is very satisfied with the treatment result.
