# CASE REPORT

## MRS-TITAN MAXIMUM

## TREATMENT OF A SIGNIFICANT BONE DEFECT CENTRALLY AND IN THE POSTERIOR COLUMN WITH A MODULAR CUP SYSTEM

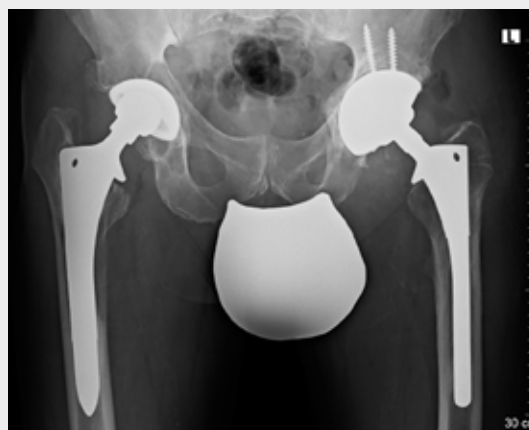
Radiological imaging and joint puncture revealed aseptic wear of the polyethylene insert, pronounced osteolysis and an acetabular defect type IIc according to Paprosky in the right hip (Fig. 1). Preservation of the cup was not possible due to the pronounced osteolysis. In addition, no polyethylene inserts were available from the manufacturer of the cup system for this cup. A revision with cup replacement in the right hip joint was indicated. In April 2024, the patient was treated with a revision cup as on the left side (Fig. 2).

Fig. 1 Pelvic overview, aseptic loosening of the cup, right hip, osteolysis.

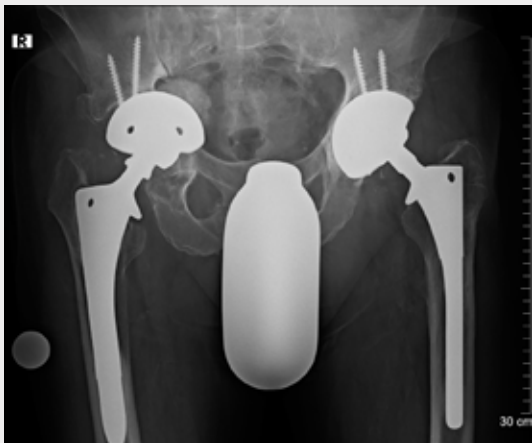
The patient complained of persistent discomfort. In October 2024, the radiological examination showed a medial cup migration compared to the previous radiographs (Fig. 3). Computed tomography (CT) diagnostics confirmed an aseptic loosening of the acetabulum cup and an acetabular defect in the area of the posterior pelvic column. The ischium was fractured and barely connected to the acetabulum (Fig. 4).

Fig. 3 Pelvic overview 6 months after cup replacement. Medial migration of the cup.

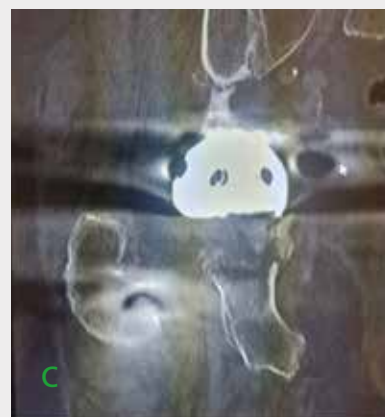
Fig. 4 Preoperative CT imaging in the frontal plane (a) and sagittal plane (b, c), acetabular defect situation.

In November 2024, the cup was revised using the Bauer lateral approach in accordance with the surgical planning. After removal of the cup, pronounced Paprosky type IIIb bone defects were found intraoperatively in the acetabular floor and area of the posterior column.

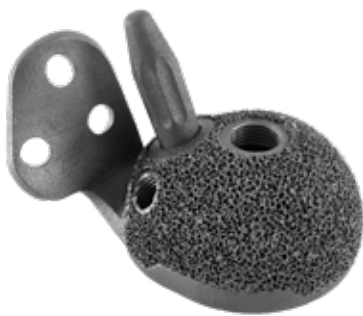
Fig. 5 MRS-TITAN Maximum with anatomically designed strap and intramedullary peg anchorage (modular iliac peg 30 mm)

The patient was surgically treated with the cementless modular revision cup MRS-TITAN Maximum (Ø 72 mm) to ensure the greatest possible stability (Fig. 5). The anatomical strap and the iliac peg (30 mm) enable primary stable anchoring of the cup.

Intramedullary stabilisation in the ilium was achieved using the intraoperatively placeable iliac peg. In addition to press-fit anchoring of the cup and strap screw fixation, cancellous screws were used. The trabecular, open-pored and rough titanium surface structure (3D printing) promotes rapid bone ingrowth for secondary stabilisation.

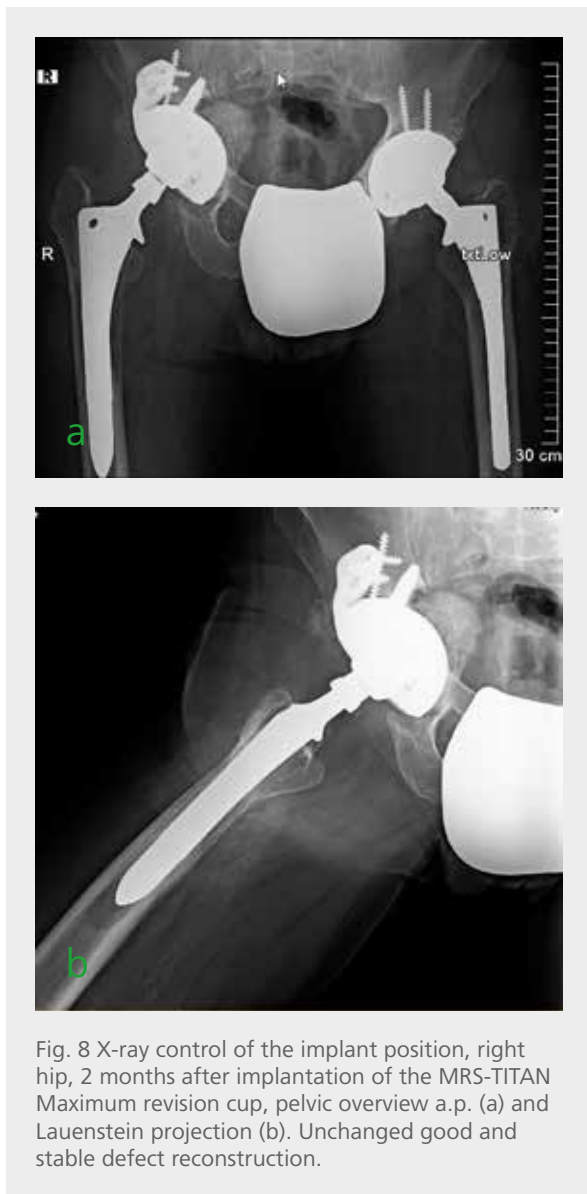
Fig. 8 X-ray control of the implant position, right hip, 2 months after implantation of the MRS-TITAN Maximum revision cup, pelvic overview a.p. (a) and Lauenstein projection (b). Unchanged good and stable defect reconstruction.

The intraoperative X-ray control confirmed the correct positioning of the implant components and stable joint conditions (Fig. 6). Both postoperatively (Fig. 7) and in the radiological follow-up 2 months after implantation (Fig. 8), the revision cup was found to be well and firmly seated.
